[Docket No. FAA-2013-0725; Directorate Identifier 98-CE-01-AD; Amendment 39-17690; AD 98-15-18 R1]

Airworthiness Directives; Maule Aerospace Technology, Inc. Airplanes

PROCEDURES AND REQUIREMENTS FOR ULTRASONIC INSPECTION OF MAULE WING LIFT STRUTS

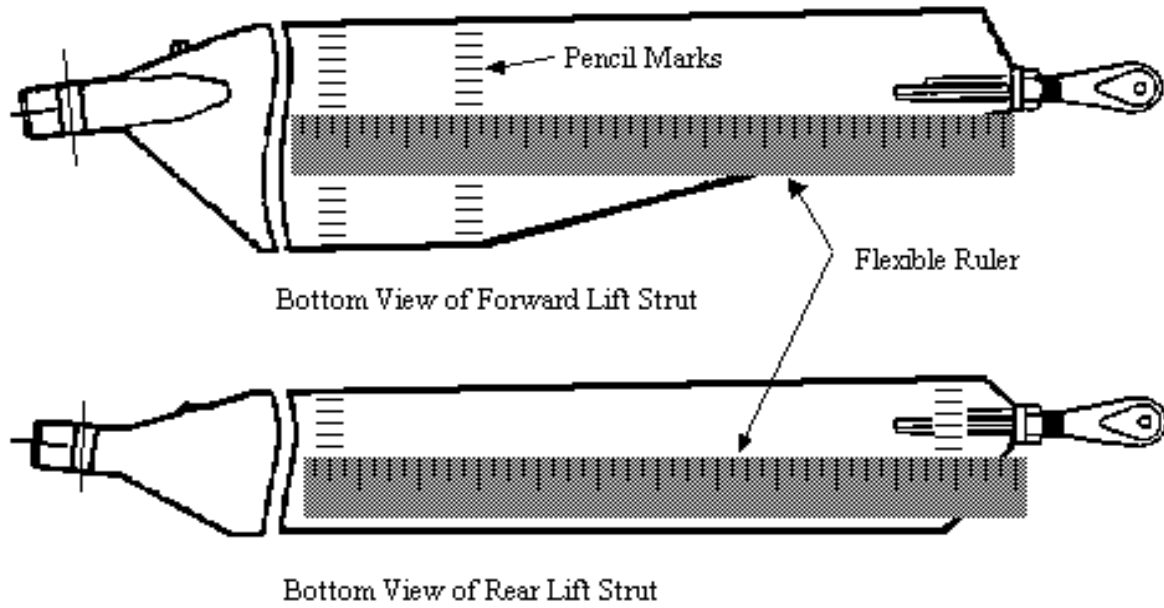
Figure 1

2. Using a flexible ruler, draw a 1/4-inch grid on the surface of the first 11 inches from the lower end of the strut as shown in Maule Air, Inc. Service Bulletin No. 11, dated October 30, 1995, as applicable. This can be done using a soft (#2) pencil and should be done on both faces of the strut. As an alternative to drawing a complete grid, make two rows of marks spaced every 1/4 inch across the width of the strut. One row of marks should be about 11 inches from the lower end of the strut, and the second row should be several inches away where the strut starts to narrow. Lay the flexible ruler between respective tick marks of the two rows and use tape or a rubber band to keep the ruler in place. See Figure 1.
